TC4 叶片裂纹及体积损伤激光修复工艺方法

摘要: 针对 TC4 合金叶片经常性表层裂纹萌生、体积损伤以及修复材料成本高的工程实际, 优选 FeCrNiB 系以及 TiAlVFe 系合金材料, 基于脉冲激光成形工艺优势, 实现了 TC4 合金叶片表层裂纹及体积损伤修复, 从成形工艺、金相组织、显微硬度以及三维尺寸等方面验证了工艺匹配性。结果表明: FeCrNiB 合金熔覆层主要由细小致密的等轴晶、交错分布的树枝晶以及均匀分布的胞状晶组成, 而 TC4 合金主要由针状马氏体和网篮组织交错伴生组成, 都具有较好的组织形态。FeCrNiB 合金熔覆层显微硬度为 380~750 HV_{0.1}, 较基体提升约 1 倍; TC4 合金熔覆层显微硬度为 295~350 HV_{0.1}, 与基体基本保持一致。叶片成形后整体形状尺寸精度控制在 0.8 mm 以下。通过激光工艺优化和性能匹配分析可知, FeCrNiB 合金适合局部微裂纹修复, 而 TC4 合金适合体积损伤成形。

Laser repairing process of TC4 blades with crack and volume damage

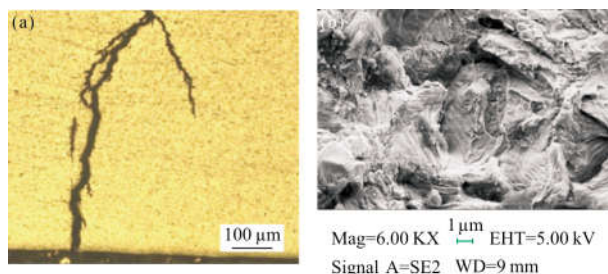
试验采用存在表层裂纹及体积损伤的 TC4 叶片为基体，其表层裂纹金相及体积损伤断口如图 1 所示，图 1(a)为叶片表层裂纹金相组织，图 1(b)为叶片体积损伤部位断口形貌。

图 1 叶片表层裂纹及体积损伤部位断口形貌

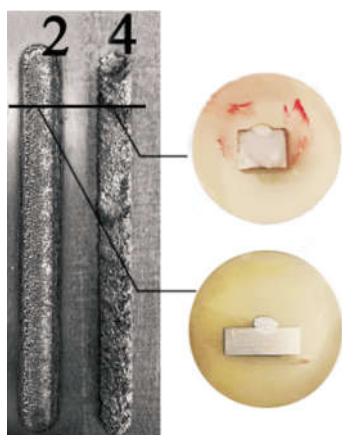
图 2 所示为表 2 中工艺对应的单道成形形貌,由该图可知,试样 2~4 均具有较好的成形形貌,而试样 1 成形高度明显不足,这主要由该工艺下激光功率偏低引起,与试样 3 相比,试样 2 成形高度更大,且稀释率相对较好,对试样 2、4 中部进行线切割取样、镶样、打磨及抛光,试样 2 采用酸性氯化铁进行腐蚀;试样 4 采用 5% 的氢氟酸溶液进行腐蚀。利用 MR5000 型倒置金相显微镜观察金相组织,采用 HVS-1000B 型显微硬度测定仪进行硬度测试。

图 2 不同工艺参数下单道熔覆宏观外貌

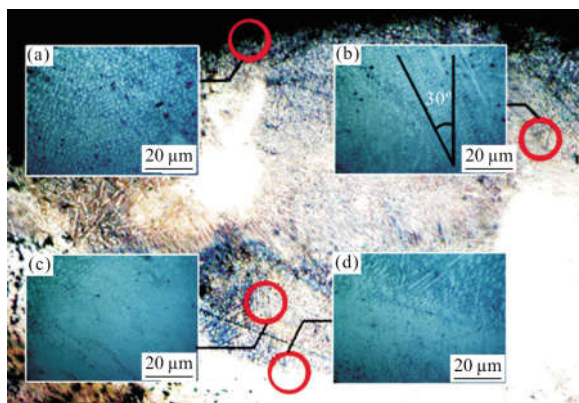
图 3 所示为 FeCrNiB 合金熔覆层金相组织,由图 3(a)可知,熔覆层顶部主要为呈均匀分布的细小致密的等轴晶,这主要是因为熔覆层顶部与周围空气直接接触,存在较大过冷度,不具备晶体充分孕育长大的条件;而图 3(b)所示为熔覆层中部位置,该部位过冷度较小,存在枝晶长大条件,因此该部位主要为呈定向生长的较为粗大的树枝晶,且受散热梯度影响,与激光熔覆方向略成 30°;图 3(c)所示为熔覆层底部为与退化的树枝晶呈交错分布的平面胞状晶,这是由于该部位与基体接近,散热条件良好,过冷度较大,树枝晶孕育生长条件被打破,向平面的胞状晶行不完全退化所致;图 3(d)所示为成形界面及基体部位,可知该部位为致密的冶金结合,基体为典型细粒状的 β 相形貌^[13-14]。综上可知,FeCrNiB 合金

熔覆层与基体结合良好,具有较好的金相组织形态,与基体具有一定差异,但适合局部微细裂纹再制造^[15]。

图 3 FeCrNiB 合金金相组织形态

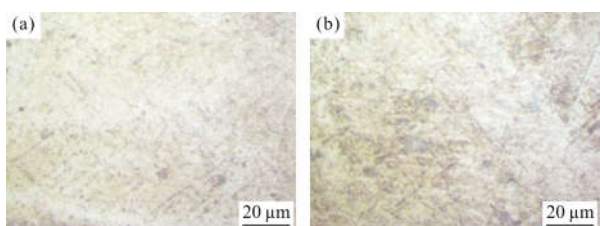
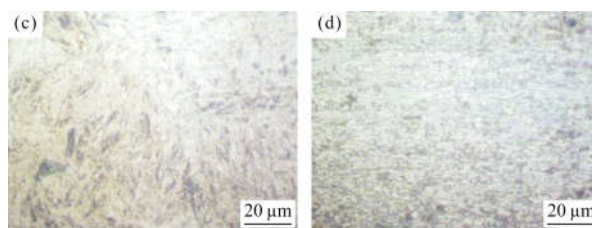
图 4(a)~(d)所示分别为 TC4 合金熔覆层顶部、中部、底部以及结合界面处金相组织,由图 4(a)~(c)可知,熔覆层内部组织以层片状 β 相组织为主,其间交错分布大量针状马氏体组织而形成网篮结构,马氏体组织的增加主要是因为熔覆层在极冷条件下,促成了奥氏体向马氏体的转变,而这一变化过程极为短暂,促成了马氏体组织的保留,该组织形态的生成利于熔覆层的硬脆性^[16];而对比图 4(b)、(c)可知,图 4(c)中网篮组织进一步增加,这主要是因为该部位与基体相接触,具有更高的散热梯度,使该部位熔化凝固成形过程中,达到了钛合金的相变点,又在相变点以下迅速凝固,使得原始 β 晶界被破坏,形成了分布更为密集的网篮组织,具有更好塑韧性和高周疲劳强度及热强性,与基体间可形成较高的结合强度。图 4(d)所示为结合界面处基体组织,为等轴 α 和片层 β 相组织,在热强性方面较网篮组织略有降低。因此,与 FeCrNiB 合金熔覆层相比较,TC4 合金在组织形态相对更为匹配,尽管再制造成本相对增加,但更适合叶片较大三维尺寸体积损伤的再制造成形。

图 4 TC4 合金熔覆层金相组织形态

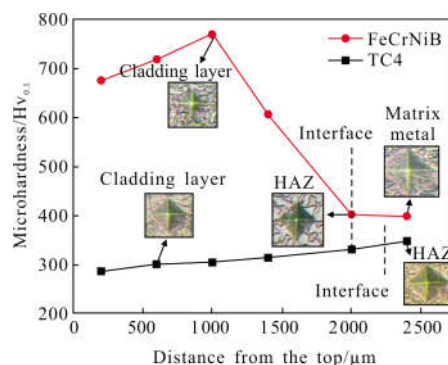
图 5 所示为 FeCrNiB 合金熔覆层和 TC4 合金熔覆层显微硬度分布,由该图可知,FeCrNiB 合金熔覆层显微硬度为 380~750 HV_{0.1},TC4 合金熔覆层显微硬度为 295~350 HV_{0.1}。其中,FeCrNiB 合金熔覆层由顶端至界面呈现递减的趋势,但显微硬度明显高于基体,这主要是由晶粒的大小和激光热输入对结合界面的软化作用共同作用引起;而 TC4 合金熔覆层从顶端至结合界面显微硬度基本保持恒定,到基体部位略有下降,这主要是因为网篮组织在熔覆层中均匀分布,而到近基体部位过渡到等轴 α 和片层 β 相混合组织引起。综上可知,两种合金熔覆层显微硬度均大于基体,TC4 合金熔覆层与基体硬度更匹配。尽管 FeCrNiB 合金显微硬度相对过大,匹配性稍差,但就叶片的局部微细裂纹再制造仍适用。

图 5 TC4 以及 FeCrNiB 熔覆层显微硬度分布

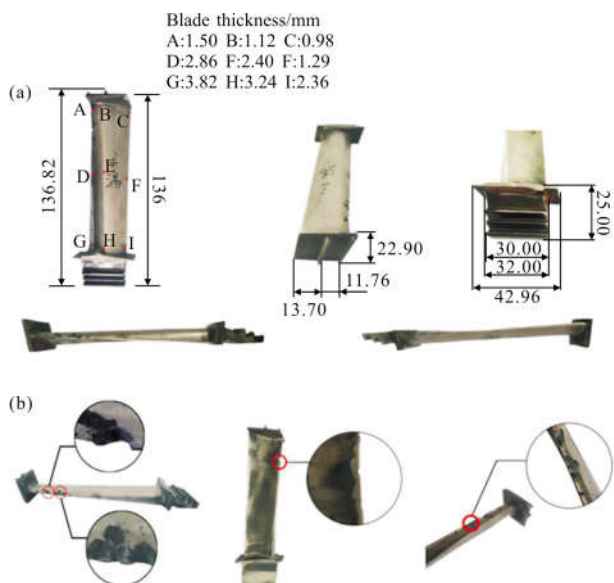
基于表 3 中不同合金材料激光优化工艺,对存在表层裂纹和边部体积损伤的叶片开展再制造成形试验,试验前体积损伤叶片整体形貌及主要三维尺

图 6 叶片表层裂纹及边部体积损伤叶片整体形貌及尺寸
 Fig.6 Overall morphology and size of surface crack and edge volume damage for the blade

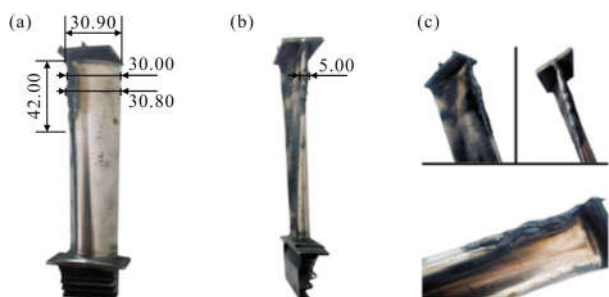
图 7 损伤叶片激光再制造后整体形貌

在实际成形过程中，为控制熔覆成形的边部塌陷出现，分别从进气边起始点 A、叶身正面点 B 及叶身背面点 C 对塌陷区域进行变角度成形，A、B 和 C 点激光光束位姿态关系以及成形后整体形貌如图 7 所示。
