## 2.79 $\mu\text{m}$ 中红外激光对CMOS图像传感器的辐照效应研究

### Irradiation effect of 2.79 $\mu\text{m}$ mid-infrared laser on CMOS image sensor

## 2.79 $\mu\text{m}$ 中红外激光对 CMOS 图像传感器的辐照效应研究

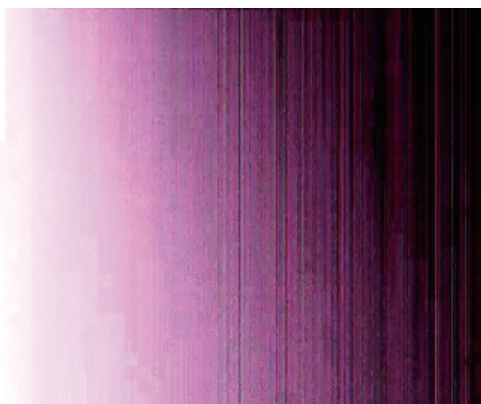
时出现过饱和现象,即全屏黑色现象,如图 4 所示。当激光能量为 820 mJ 时,经过 11 s 的辐照出现饱和现象,14 s 出现过饱和现象。在停止激光辐照一段时间后,图像传感器可以自动恢复至正常的工作状态。

图 4 传感器的过饱和和黑屏画面

Fig.4 Phenomenon of oversaturation

荷,使得势阱被逐渐填满,CMOS 输出的电压信号饱和,从而出现视频画面逐渐变白,从而出现饱和现象,此时的激光能量密度即为饱和阈值。当入射激光强度高于饱和阈值、但未使得传感器发生不可逆的损坏时,传感器出现过饱和现象。CMOS 图像传感器集成了列级相关双采样 CDS(Correlated Double Sampling)输出电路,当入射激光强度高于饱和阈值时,将影响 CDS 中参考信号(res)的采集,参考信号电压  $V_{res}$  升高,信号电压  $V_{sig}$  与参考电压  $V_{res}$  差值减小,输出视频信号受到干扰,从而导致强光辐照下器件出现过饱和现象,表现为从白色转变为全屏黑色,此时的激光能量密度为过饱和阈值。

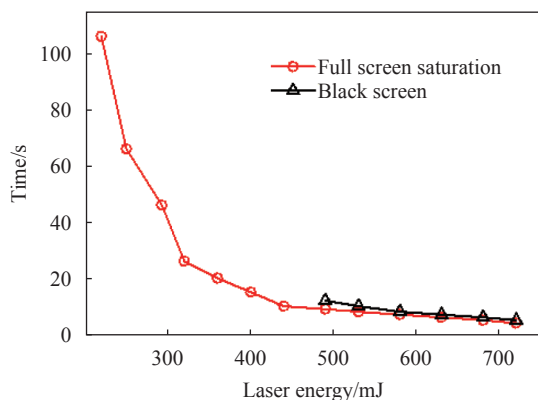
在激光重频 10 Hz 辐照下,随着重频的升高,饱和现象和过饱和现象出现的时间如图 5 所示。当激光能量为 220 mJ 时,对应的能量密度为 0.44 J/cm<sup>2</sup>,经过 108 s 的辐照传感器出现饱和现象全屏白色。当激光能量为 490 mJ 时,对应的能量密度为 0.97 J/cm<sup>2</sup>,经过 11 s 的辐照出现饱和现象,16 s 出现过饱和现象全屏黑色。当激光能量为 0.72 J 时,对应能量密度为 1.43 J/cm<sup>2</sup>,传感器经过 5 s 的辐照出现饱和现象,经过 7 s 的辐照出现过饱和现象。

图 5 干扰现象随激光能量的变化情况 (重频 10 Hz)

Fig.5 Time of irradiation effect vs. laser energy (Repetition frequency 10 Hz)

另外,实验研究表明,重频提高后,由于更多激光脉冲涌入的累积效应,使得 CMOS 图像传感器达到全屏饱和或过饱和所需的激光能量更小,时间更短。

saturation or oversaturation of full screen (Fig.5). The experimental results of laser damage show that the phenomenon of saturation, oversaturation, black screen, green screen and bright line are observed with different laser repetition frequency (Fig.8-9). The damage morphology shows that obvious melting damage occurs in the irradiation area of laser spot, and the high laser energy in the center of beam leads to the ablation and evaporation of a large area of pixel material, and the periphery of the spot area is obviously heated, but no cracks appear (Fig.10). It shows that the damage of 2.79  $\mu\text{m}$  mid-infrared laser on CMOS sensor is mainly due to the thermal melting of materials, and the thermal effect is obvious.

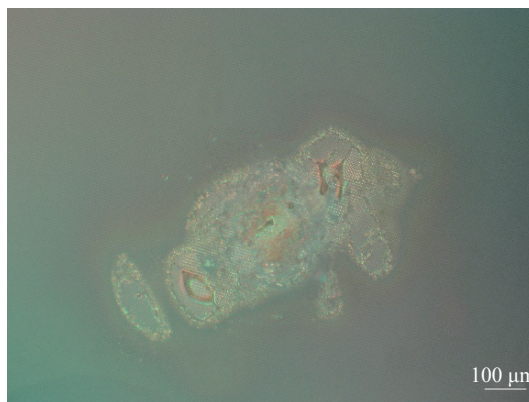
激光辐照后,CMOS 图像传感器在微干涉显微镜下观察到的损伤形貌如图 10 所示。可以观察到,激光光斑辐照区域出现了明显的熔融损伤,辐照中心区域激光能量过高导致大片像元材料烧蚀蒸发,区域外围受热明显,但未出现裂纹。说明  $2.79 \mu\text{m}$  中红外激光对 CMOS 传感器的损伤主要以材料的热熔融为主,热效应明显,传感器表面的光敏阵面以及部分信号传输电路遭到高温破坏,使得信号的选通、输出发生障碍,探测能力下降并出现上述“绿屏”、“彩色条

图 10 传感器的损伤形貌 ( $203.71 \text{ J/cm}^2$ , 10 Hz)

Fig.10 Damage morphology of CMOS image sensor ( $203.71 \text{ J/cm}^2$ , 10 Hz)

纹”画面。

开展了不同重频下 2.79  $\mu\text{m}$  中红外激光对 CMOS 图像传感器的辐照效应实验,观察到全屏饱和、过饱和和黑屏以及损伤产生的绿屏、彩色条纹、黑屏亮线等一系列干扰损伤现象,讨论了激光干扰损伤机理。实验研究表明:激光重频对干扰效果影响很大,高重频下 CMOS 图像传感器达到全屏饱和或全屏黑屏所需的激光能量更小,时间更短。2.79  $\mu\text{m}$  中红外激光对 CMOS 传感器的损伤主要以材料的热熔融为主,热效应明显。
