纳秒激光脉冲辐照太阳能电池损伤特性及对光电转化的影响

Damage characteristics of the solar cells irradiated by nanosecond pulsed lasers and the effects on photoelectric conversion

摘要: 针对纳秒脉冲激光辐照三结 GaAs 太阳能电池损伤特性及对光电转化影响开展研究。从损伤形貌、伏安特性、电致发光三个方面建立实验系统, 分别从材料烧蚀形貌、电性能输出、内部损伤情况来分析电池光电性能逐渐下降特性。在分析了激光能量密度影响的基础上, 进一步分析了激光辐照部位的影响, 如电池栅线与非栅线部位。纳秒脉冲激光由于峰值功率较高, 能对电池产生明显损伤, 激光辐照电池的栅线部位损伤效果强于辐照非栅线部位, 主要由于栅线电极的作用是用于光生载流子的收集, 激光辐照熔断电池栅线, 降低电池输出功率。研究结论对于提高太阳能电池空间防护能力具有指导意义。

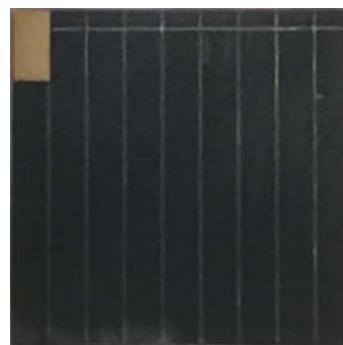
典型三结 GaInP₂/GaAs/Ge 电池如图 1 所示，电池

表面分布有金属栅线条状电极，样品尺寸为 $1 \text{ cm} \times 1 \text{ cm}$ 。电池主要结构为表面的栅线电极、抗反射膜、GaInP₂ 层顶电池、GaAs 层中电池、Ge 层底电池以及底部的电极。

图 1 三结 GaInP₂/GaAs/Ge 电池样品

Fig.1 Three-junction GaInP₂/GaAs/Ge cell sample

太阳能电池的表面分布有多条金属栅线电极，电池在光照下会源源不断地产生光生载流子，为了将光生载流子利用起来形成循环电流，需要在太阳能电池的正负极通过栅线电极收集载流子，从而在正负电极导通形成电流循环通道。由于太阳能电池需要受到光照才能产生光生载流子，所以在设计表面电极时会将电极设计为栅线状，一方面能够收集载流子导通正负电极，另一方面是留有未覆盖区域方便太阳能电池吸收光照能量。可以看出，电极栅线是太阳能电池的重要部位，因此在研究激光辐照太阳能电池的损伤特性时，需要考虑激光辐照部位分别为非栅线部位和直接辐照栅线时的区别影响。

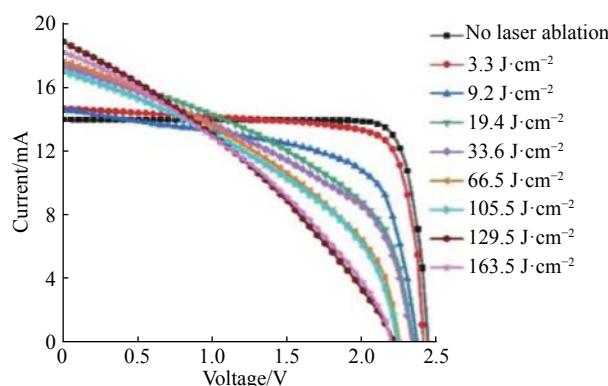
图 2、图 3 分别为不同激光能量密度辐照后太阳能电池的伏安特性曲线和功率电压关系曲线,可以看出均发生了程度不同的衰减,其中激光能量密度越大,伏安特性曲线和功率电压关系曲线下降越明显。

图 2 激光辐照三结 GaInP₂/GaAs/Ge 电池非栅线部位的伏安特性变化曲线

Fig.2 Variation curves of voltage-current characteristics of the non-gate line part of a triple-junction GaInP₂/GaAs/Ge cell irradiated by laser

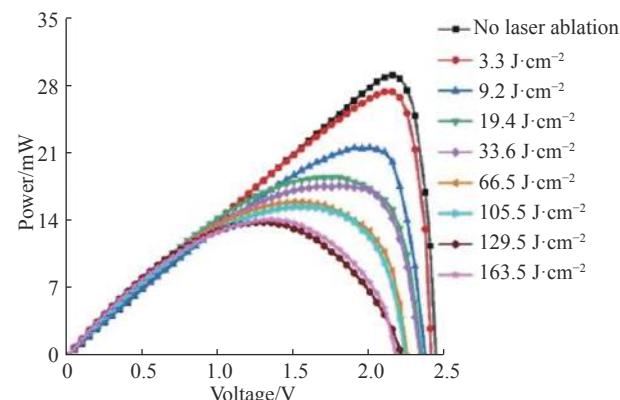
图 3 激光辐照三结 GaInP₂/GaAs/Ge 电池非栅线部位的功率电压特性变化曲线

Fig.3 Variation curves of power-voltage characteristics of the non-gate line part of a triple-junction GaInP₂/GaAs/Ge cell irradiated by laser

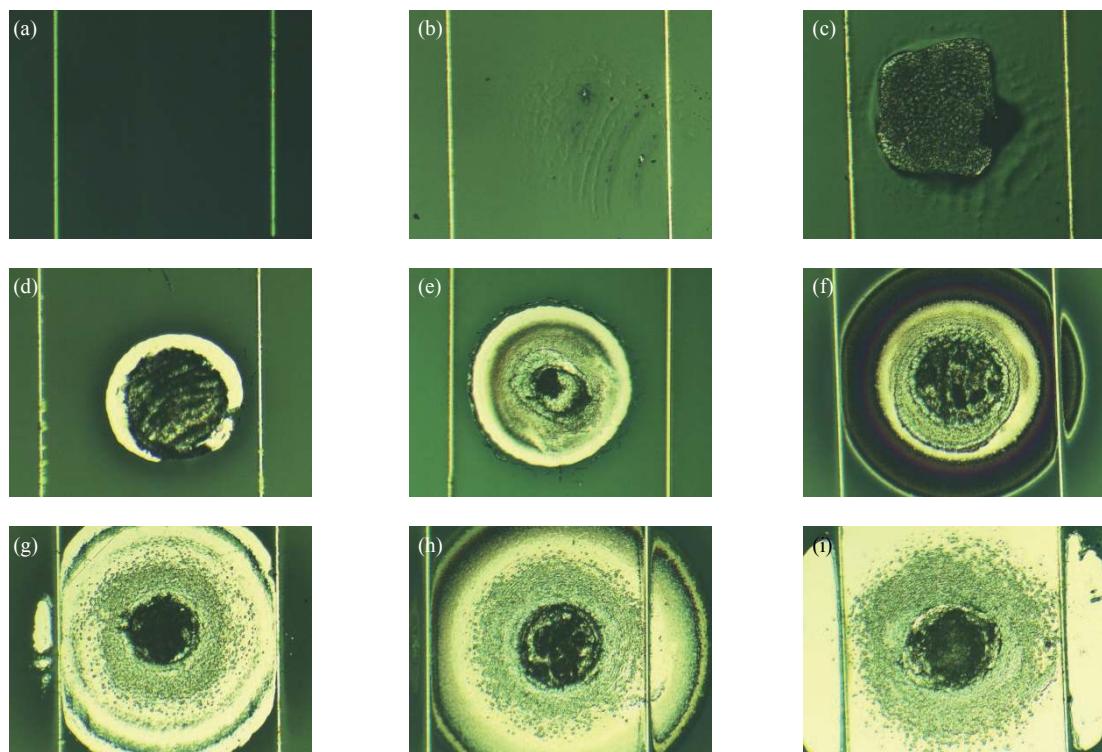
激光辐照过后电池的表面形貌变化如图 4 所示,可以发现:随着激光能量密度的增加,损伤区域逐渐增大。纳秒高能量密度激光辐照太阳能电池的损伤主要以热损伤为主,由于能量迅速沉积,导致光斑中心处电池材料熔融气化,由于激光脉冲持续时间在纳秒量级,激光脉宽远大于材料能量弛豫时间,热扩散作用显著,脉冲激光结束辐照后,烧蚀产物将很快由熔融状态转换到凝固状态,烧蚀产物的熔融再凝固以及由于热扩散作用导致周围区域温度低于材料熔点而发生的氧化还原反应,共同形成了周边环状区域,周边环状区域、中心区域为烧蚀形成的烧蚀坑,激光

能量密度越高对应烧蚀坑及周围环状区域越大。

图 4 纳秒激光辐照三结 $\text{GaInP}_2/\text{GaAs}/\text{Ge}$ 电池非栅线部位的形貌变化。(a) 电池的原始形貌; (b)~(i) 激光能量密度为 $3.3, 9.2, 19.4, 33.6, 66.5, 105.5, 129.5, 163.5 \text{ J}\cdot\text{cm}^{-2}$ 时激光辐照的形貌变化

Fig.4 Morphology changes of the non-gate line part of the triple junction $\text{GaInP}_2/\text{GaAs}/\text{Ge}$ cell irradiated by nanosecond laser. (a) Original shape of the cell; (b)~(i) Morphology changes by laser irradiation when laser energy density is $3.3, 9.2, 19.4, 33.6, 66.5, 105.5, 129.5, 163.5 \text{ J}\cdot\text{cm}^{-2}$ respectively

当纳秒脉冲激光辐照电池非栅线部位时, 电池具有较好的抗损伤能力。表面形貌测量表明, 光斑辐照中心形成明显烧蚀坑, 且烧蚀坑周围存在热扩散影响造成的环状区域, 激光能量密度越大, 环状区域越大。电池电致发光图像表明, 电池内部损伤面积随着激光能量的增加而增大, 电致发光强度下降趋势与电池最大功率下降趋势基本相同。

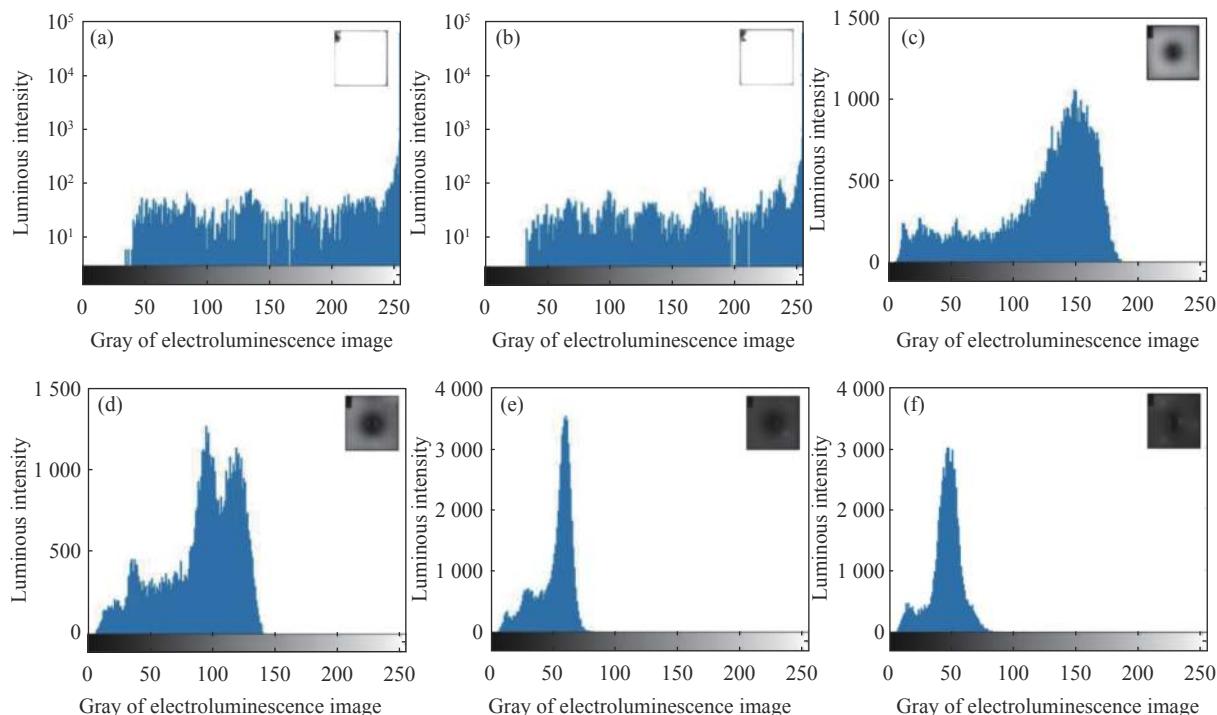
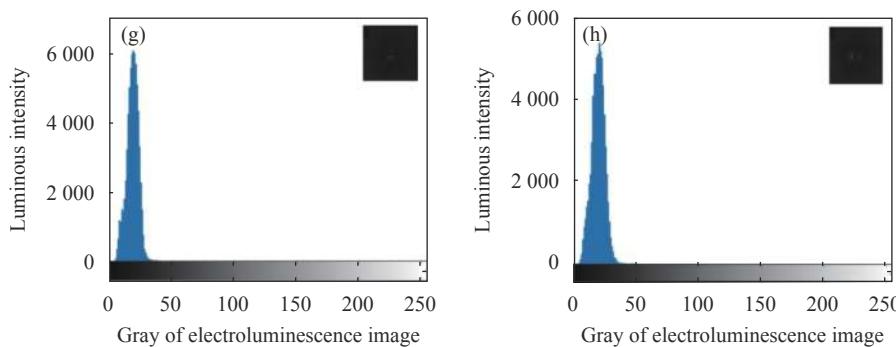
在正向偏置电压 3 V 的条件下,使用电致发光检测相机,拍摄不同激光能量密度辐照后三结 GaInP₂/GaAs/Ge 电池的电致发光情况,获得电池内部损伤情况,如图 5 所示。利用太阳能电池电致发光的灰度值来表示电池在不同损伤程度后的发光情况,进而来判断太阳能电池的损伤特性,图中横坐标为电致发光灰度图的灰度值,纵坐标为灰度值在图像中出现的次数,右上角为太阳能电池电致发光图像。当太阳能电池未受到损伤时,电池的发光强度最高,当电池受到损伤后,发光强度降低,灰度值分布会向左移动。

通过对电致发光结果的分析可以发现:电池的发光强度随着激光能量密度的升高而降低,电致发光图像可以观测到电池的损伤影响区,激光能量密度较低时的损伤影响区域主要分布在激光辐照部位周围,随着激光能量密度的升高,影响区范围逐渐增大,直到扩散到整个电池。电致发光图像结果表明,尽管激光烧蚀的是电池表面一小块区域,但是太阳能电池较大范围内都会受到损伤影响。

图 5 纳秒激光辐照三结 $\text{GaInP}_2/\text{GaAs}/\text{Ge}$ 电池非栅线部位的电致发光变化。(a) 激光未辐照时的电致发光结果; (b)~(h) 激光能量密度为 3.3 、 19.4 、 33.6 、 66.5 、 105.5 、 129.5 、 $163.5 \text{ J}\cdot\text{cm}^{-2}$ 时的电致发光结果

Fig.5 Electroluminescence changes of the non-gate line part of the triple junction $\text{GaInP}_2/\text{GaAs}/\text{Ge}$ cell irradiated by nanosecond laser.
(a) Electroluminescence results with no laser ablation; (b)~(h) Electroluminescence results by laser irradiation when laser energy density is 3.3 , 19.4 , 33.6 , 66.5 , 105.5 , 129.5 , $163.5 \text{ J}\cdot\text{cm}^{-2}$ respectively

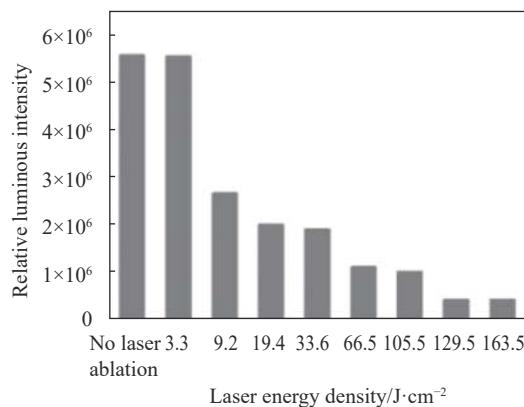
为了量化比较激光辐照过后电池的电致发光强度变化,将同一张电致发光图中每个像素点的灰度值累加求和,得到相对发光强度,对比不同能量密度激光辐照后电池电致发光的相对发光强度。不同能量密度纳秒激光辐照三结 GaInP₂/GaAs/Ge 电池非栅线部位后,电池的电致发光相对发光强度如图 6 所示。可以发现,太阳能电池的相对发光强度随着激光能量

密度的升高先快速下降, 随后下降速度变缓。通过对比太阳能电池的电性能变化可以发现, 该趋势与电池

的最大功率变化趋势相同。因此, 电致发光图像检测可以在一定程度上反映电性能输出的变化趋势。

图 6 激光辐照三结 $\text{GaInP}_2/\text{GaAs}/\text{Ge}$ 电池非栅线部位的相对发光强度变化

Fig.6 Relative luminous intensity changes of the non-gate line part of the three-junction $\text{GaInP}_2/\text{GaAs}/\text{Ge}$ cell irradiated by laser

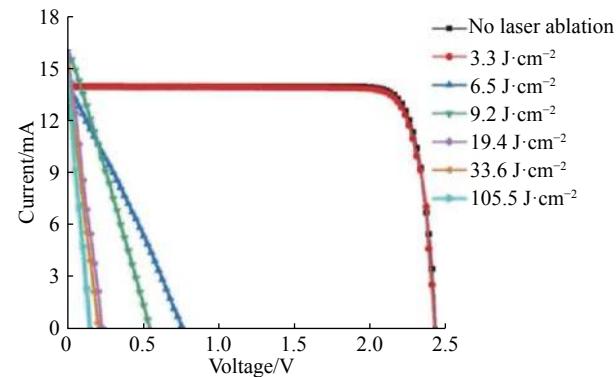
图 7、图 8 分别为激光辐照三结 $\text{GaInP}_2/\text{GaAs}/\text{Ge}$ 电池栅线后的伏安特性和功率电压关系图, 可以看出, 激光能量密度较低时, 脉冲激光辐照很难影响电池电性能, 但一旦超过 $3.3 \text{ J}/\text{cm}^2$, 电池电性能急剧下降。

图 7 激光辐照三结 $\text{GaInP}_2/\text{GaAs}/\text{Ge}$ 电池栅线部位的伏安特性变化曲线

Fig.7 Variation curves of voltage-current characteristics of the gate line part of a triple-junction $\text{GaInP}_2/\text{GaAs}/\text{Ge}$ cell irradiated by laser

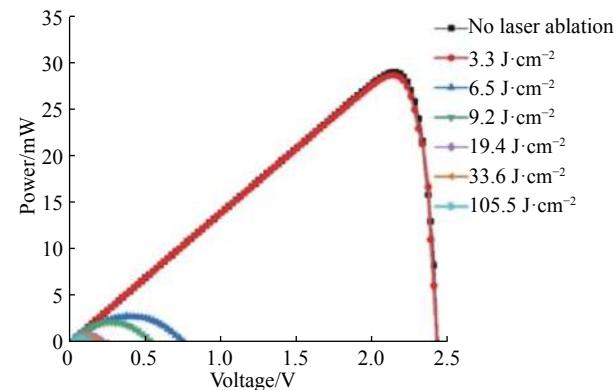
图 8 激光辐照三结 $\text{GaInP}_2/\text{GaAs}/\text{Ge}$ 电池栅线部位的功率电压特性变化

Fig.8 Variation curves of power-voltage characteristics of the gate line part of a triple-junction $\text{GaInP}_2/\text{GaAs}/\text{Ge}$ cell irradiated by laser

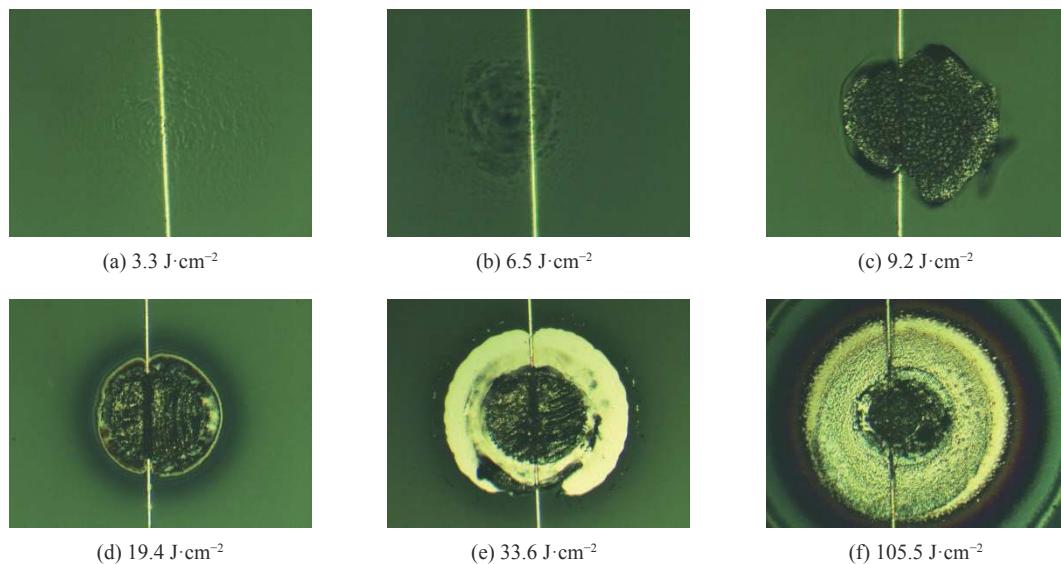
不同能量密度激光辐照栅线电极后电池的表面形貌如图 9 所示, 可以发现, 能量密度 $3.3 \text{ J}/\text{cm}^2$ 的激光辐照后, 太阳能电池表面产生轻微烧蚀变化, 但未产生明显损伤。进一步提高激光能量密度到 $6.5 \text{ J}/\text{cm}^2$ 后, 太阳能电池表面栅线附近出现轻微损伤。随着激光能量密度的提高, 激光辐照导致的栅线处烧蚀坑越来越大, 并且由于材料熔融再凝固以及由于热扩散作用导致周围区域温度低于材料熔点而发生的氧化还原反应, 共同形成了周边环状区域, 激光能量密度越

高, 对应烧蚀形成的环状区域越大。

图 9 不同激光能量密度纳秒激光辐照三结 GaInP₂/GaAs/Ge 电池栅线的形貌变化

Fig.9 Morphology changes of the gate line part of the triple junction GaInP₂/GaAs/Ge cell irradiated by nanosecond laser with different laser energy densities

当激光辐照电池栅线部位时, 损伤效果强于辐照非栅线部位, 激光能量密度 19.4 J/cm^2 辐照后电池便几乎完全损伤。主要由于栅线电极受到激光辐照熔断所致, 栅线电极主要用于收集光生载流子, 熔断后电池光电转换能力显著下降。表面形貌测量显示, 激光辐照后电池栅线被熔断, 且形成烧蚀损伤区域。电池电致发光图像显示, 电池电性能大幅度下降后失去电致发光能力, 电致发光强度的下降规律与最大输出功率降趋势基本相同。

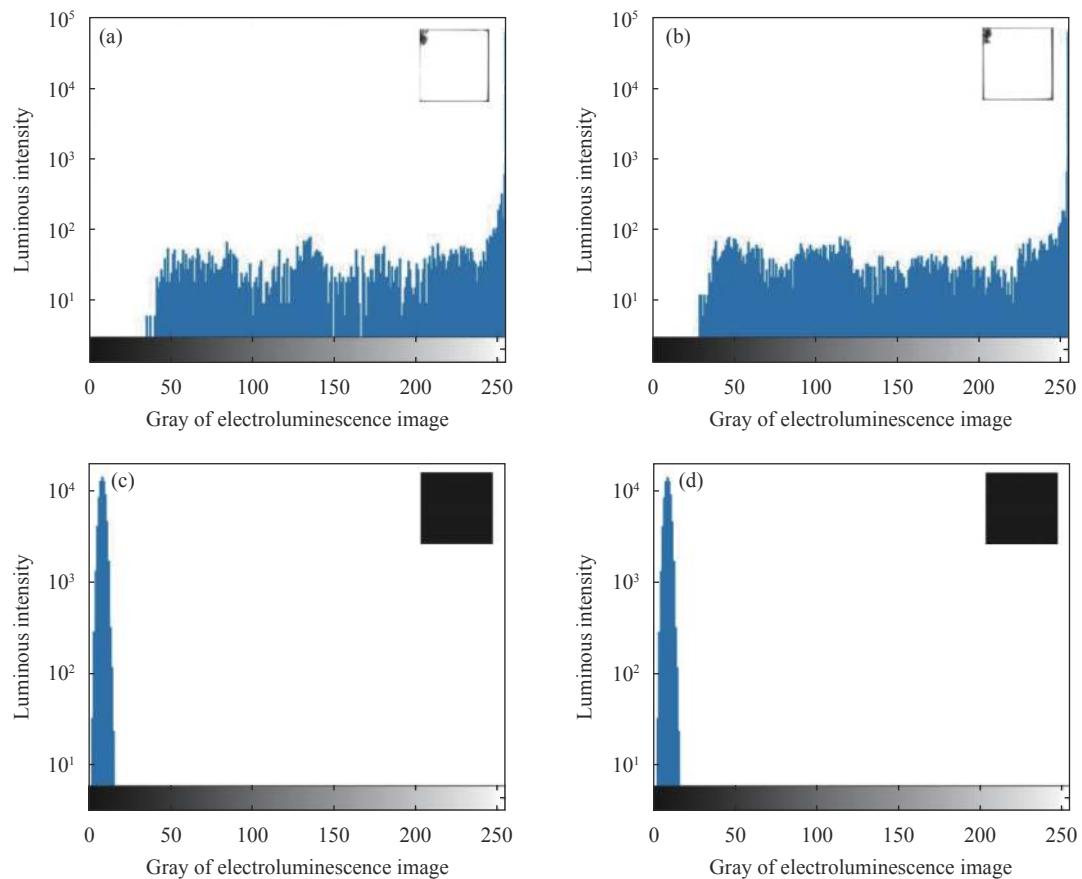
不同能量密度激光辐照三结 $\text{GaInP}_2/\text{GaAs}/\text{Ge}$ 电池栅线后, 电池的电致发光情况如图 10 所示, 能量密

图 10 纳秒激光辐照三结 GaInP₂/GaAs/Ge 电池栅线部位的电致发光变化。(a) 激光未辐照时的电致发光结果; (b)~(d) 激光能量密度为 3.3、6.5、105.5 J·cm⁻² 的电致发光结果

Fig.10 Electroluminescence changes of the gate line part of the triple junction GaInP₂/GaAs/Ge cell irradiated by nanosecond laser.
 (a) Electroluminescence results with no laser ablation; (b)-(d) Electroluminescence results by laser irradiation when laser energy density is 3.3, 6.5, 105.5 J·cm⁻² respectively

度 3.3 J/cm^2 激光辐照后, 电致发光未产生明显变化, 与电性能未明显变化相对应; 激光能量密度提高到 6.5 J/cm^2 后, 电致发光图如图 10(c) 所示, 此时太阳能电池失去电致发光能力, 表现为直方图整体左移到最左端, 对应电性能变化表现为最大功率产生急剧下降。进一步提高激光能量密度后太阳能电池的电致发光图像反映的结果依然表现为灰度值极低, 显然, 此时电致发光结果表现为损伤达到饱和。

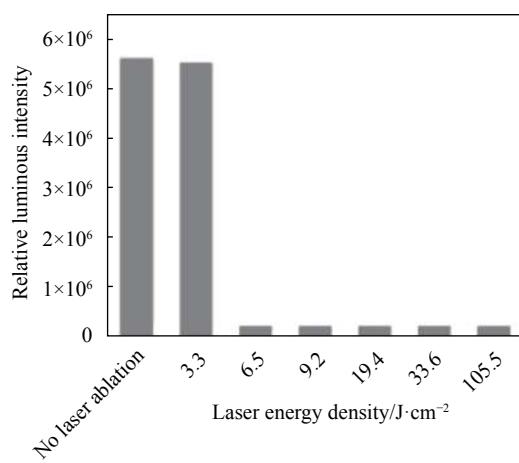
不同激光能量密度辐照后电池的电致发光相对强度变化结果如图 11 所示, 发光强度随激光能量密度的变化较为敏感, 实验中能量密度达到 6.5 J/cm^2 时, 激光辐照后电池近乎失去电致发光能力, 电致发光的下降规律与最大输出功率下降规律类似。

图 11 激光辐照三结 $\text{GaInP}_2/\text{GaAs}/\text{Ge}$ 电池栅线部位的相对发光强度变化

Fig.11 Relative luminous intensity changes of the gate line part of the three-junction $\text{GaInP}_2/\text{GaAs}/\text{Ge}$ cell irradiated by laser
